Surface finish of temporary crowns and bridges with Luxatemp-Glaze & Bond

Example case

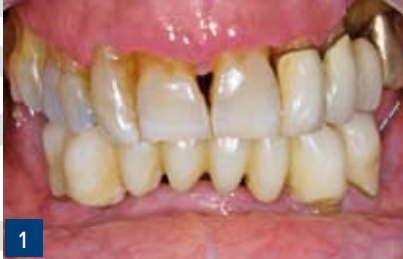
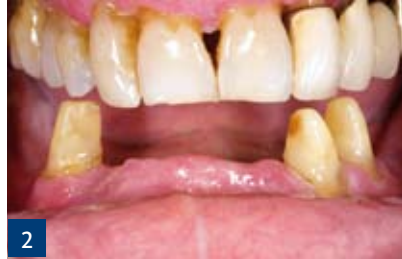
Initial situation after a treatment performed alio loco with an insufficient temporary (Figs. 1+2). A situation impression is taken with StatusBlue® (DMG, Hamburg). Following the fabrication of a model and filling of the undercontoured areas on the model, a vacuum formed template was made for the fabrication of the temporary (Fig. 3).

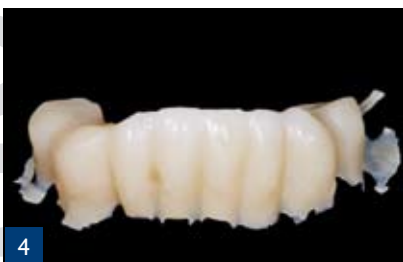
A shade was selected for the new temporary: for the incisal area one layer of Luxatemp®-Fluorescence Bleach light, for the central area colour A2 and for the cervical area colour A3.5 to match the natural shading of the teeth (Fig. 4).

The removed temporary reveals the color gradient from the incisal to the cervical area.

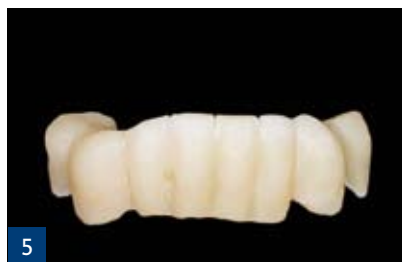
The next step includes the finishing of the cervical, approximal, and incisal areas by slightly separating the incisal edges and allowing sufficient space for the cervical papilla (Fig. 5).

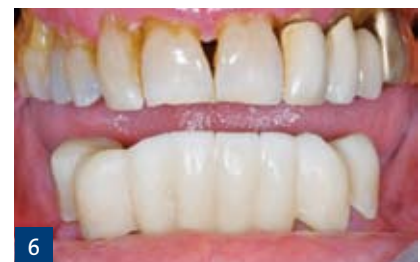
The fit and occlusion is evaluated intraorally and optimized if needed (Fig. 6).

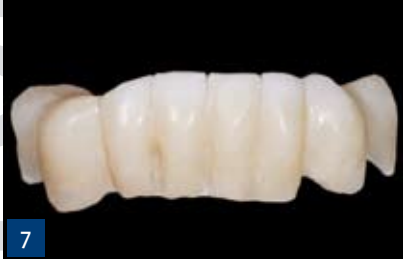
The restoration in the fourth quadrant is finished with a conventional polish, and, in the following image, contrasted to the area in the third quadrant which was treated with burs only (Fig. 7).

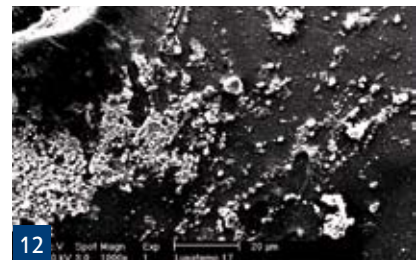
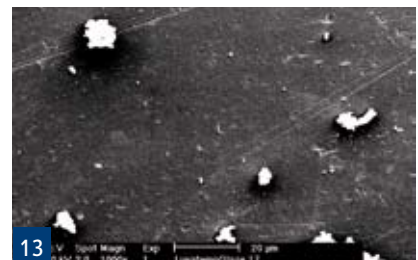
A clinical study by Mues et al. (DZZ, 3/2008) clearly revealed the plaque reducing effect of the varnish. The following SEM images show the surface of a polished and a varnished temporary after a wearing time of ten days each (Figs. 12+13).
